BRIDGE INSPECTION REPORT

Date Inspected: May 20th to May 23rd, 2024

Grosse Ile Toll Bridge

Structure Number: 12306

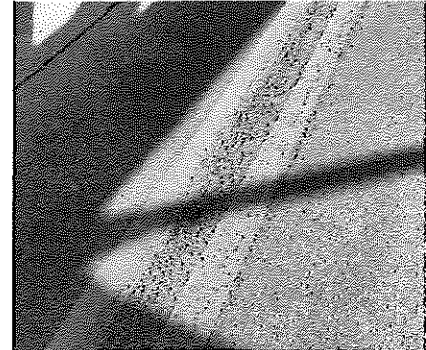
The fixed spans are filled grid decks with an overpour. The deck surface on the fixed spans is in fair condition. The concrete is noticeably worn down in the path of traffic and the aggregates are beginning to show. There are many minor popouts in the concrete scattered around the centerline between lanes of traffic and near the outside edges of the lanes on Span 4, as shown in Photo S-01. The most severe longitudinal crack is located [REDACTED]

Photo S-01 [Span 4] Minor popouts at center line of bridge, looking west

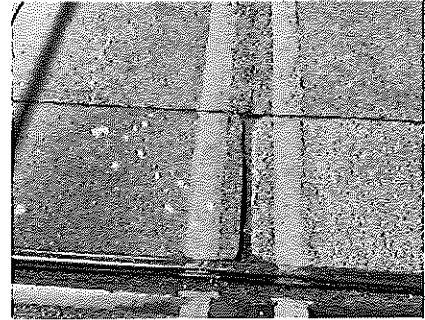
The joints on this structure are overall in fair condition. Large areas of spalling exist at both open joints of the Swing Span. [REDACTED]

Photo S-04 [Span 4] Concrete spalling at joint between Span 3 and 4, looking west

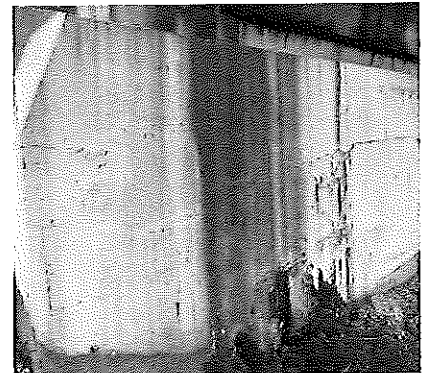
The east abutment is in good condition. The west abutment is also in good condition. Hairline cracks exist throughout both abutment walls (Photo S-19).

Photo S-19 [East Abutment]
West face of East Abutment,
hairline cracks

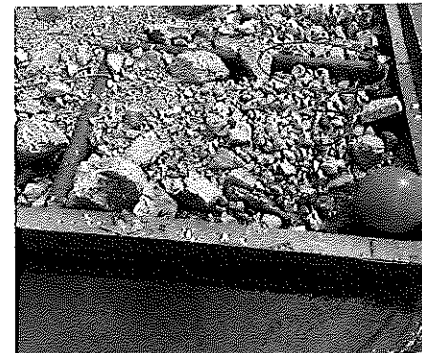
The north pier protection cell is in good condition. The south pier protection cell is in fair condition. The filling is sinking inside the south cell, and longitudinal cracks exist along the HSS bracing throughout the cell, shown in Photo S-20.

Photo S-20 [Swing Span] South
pier protection cell, filling
sinking, cracked weld on HSS
bracing, looking south

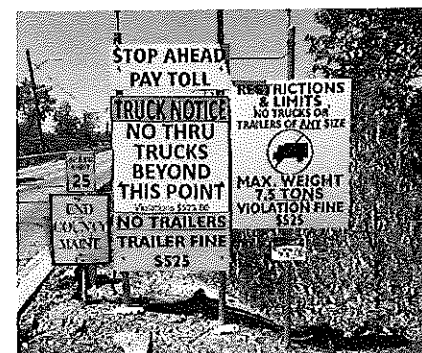
The bridge signage is in good condition. The signage on the east and west side of the bridge are clearly visible (Photo S-21).

Photo S-21 Signage at the east
approach of the bridge

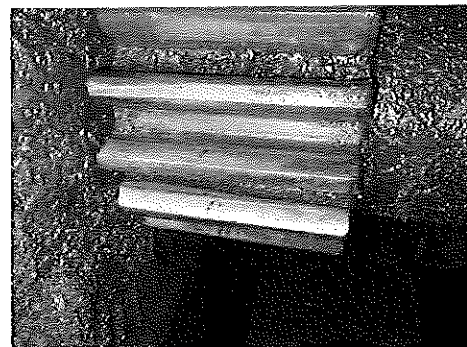
M01: Motor Pinion MP1

The motor gearset consists of MP1 and GP1. MP1 is connected to the motor shaft and exhibits plastic deformation at the pitch and tip of the tooth line. There is light scoring, and the wear is more excessive on the inboard side (motor side). This is shown in Photo M01.

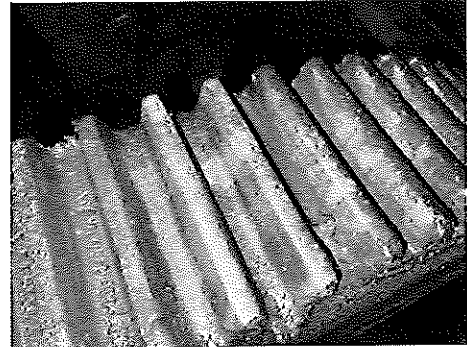
M02: Motor Gear MG1

The teeth are also polished. GP1 has moderate rust at the ends of the gear teeth. There is scoring throughout the teeth and the end of the teeth are rounded from wear. The gear teeth exhibit plastic flow at the pitch line and the ends of the teeth are battered, likely from the root and tip of the teeth interfering. This is shown in Photo M02.

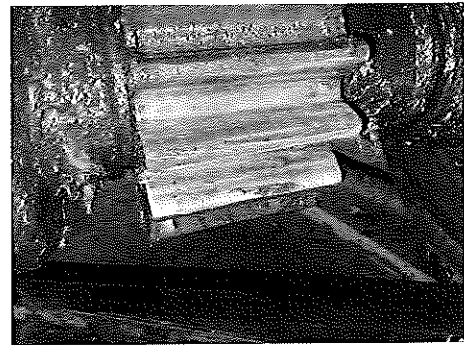
M03: Pinion P1

P1 exhibits severe plastic flow at the pitch line that has caused the tooth to appear dented. It also shows heavy finning, moderate scoring, and light rust at the root. G1 has surface rust, plastic deformation and finning at the tip on the outboard (non-motor side). The teeth also have light to moderate scoring and the edges are rounded from plastic flow. P1 and G1 are shown in Photo M03 and Photo M04.

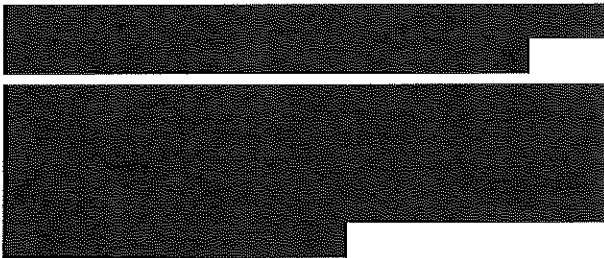
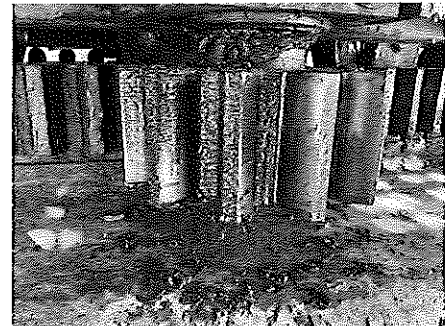
M09: Main Pinion – West

The main pinion on the west side is in fair condition. Unlike the main pinion on the east side, the west side pinion is not shrouded. The pinion has moderate scoring and some finning. The rack on the west side is also in fair condition. There is some surface rust and, similar to the east side, there are areas of weld repairs. The west

main rack and pinion conditions are shown in Photo M09 and Photo M10.

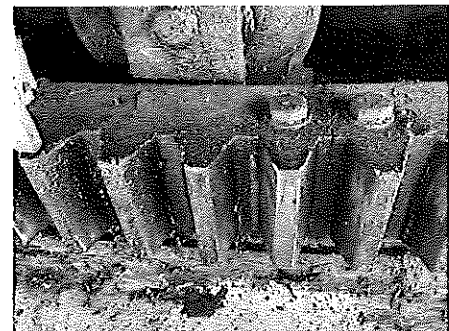
M11: Rack segments not fully bearing

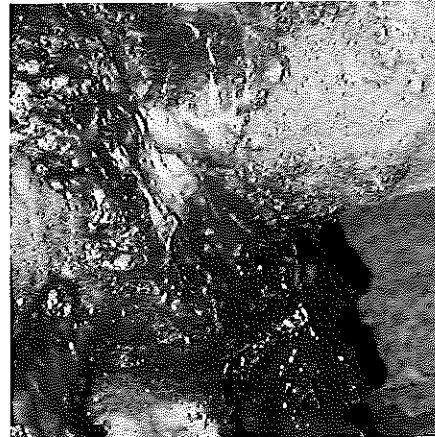
P4 and G4 are part of the end lift machinery. They are rusted and the tips of the teeth are rounded and chipped off. They have heavy scoring, finning, and plastic flow at the tips. Plastic flow is across the entire face of G4. There is plastic deformation from contamination. P4 and G4 are seen in Photo M17 and Photo M18.

M19: Gear G4 loose on shaft

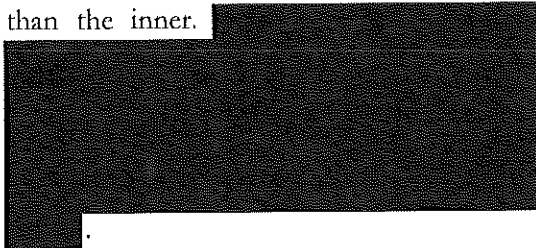
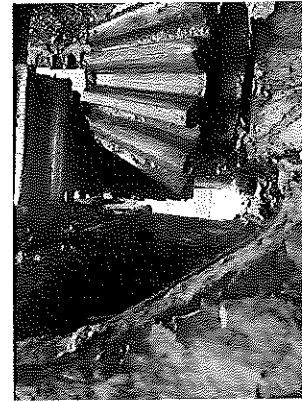
M20: BP1 – East

BP1 on the east has finning and plastic flow/deformation. The cleaned tooth of BG1 also appears to be indented where it is in contact with the bevel gear BP1. There is also surface rust throughout. BG1's teeth are rounded due to plastic flow. The gear teeth are rusted and there is heavy scoring. The gear is heel bearing, meaning that the ends of the teeth at the outer diameter are more worn than the inner.

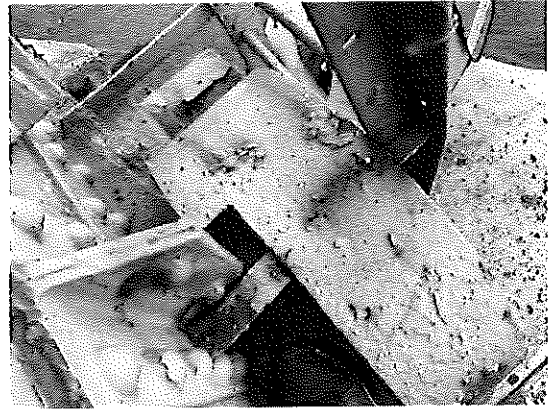
The ladder on the NE side was broken as shown in Photo M37.

M37: NE ladder broken

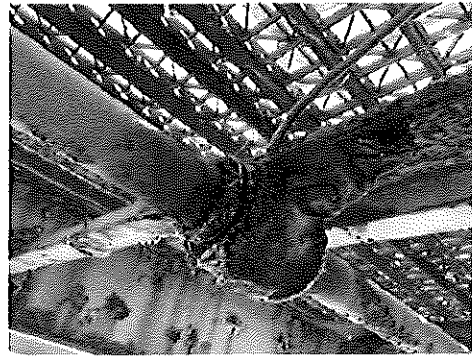
M49: B11 – W

All end lift machinery bearing clearances were measured where accessible. Overall, the bearings are in poor to fair condition. There is pack rust between the bearings and the bearing support beams, and the fasteners are corroded.

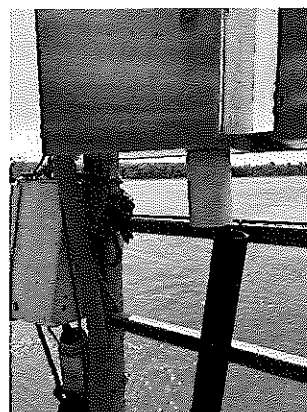
Photo E-11 [Pivot Pier] Duct
cable coming loose

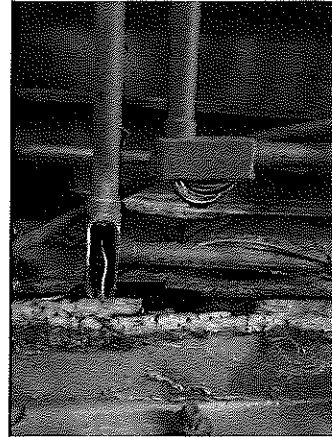
Multiple conduit covers are missing on the movable span conduit system (Photo E-12).

Photo E-12 [Pivot Pier] Typical conduit missing cover

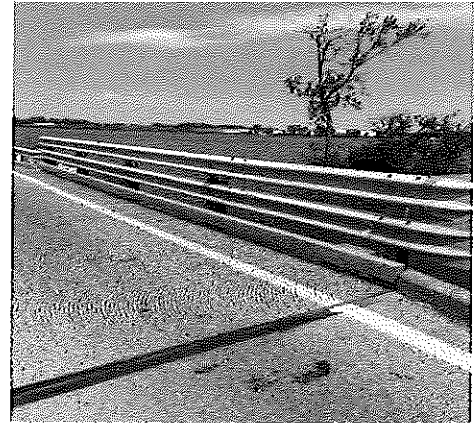
The railings are in good condition, but do not meet MDOT standard requirements. These will need to be updated to MDOT code when a deck replacement (5-10 years) or bridge replacement (15-20 years) are necessary.

Typical Railing

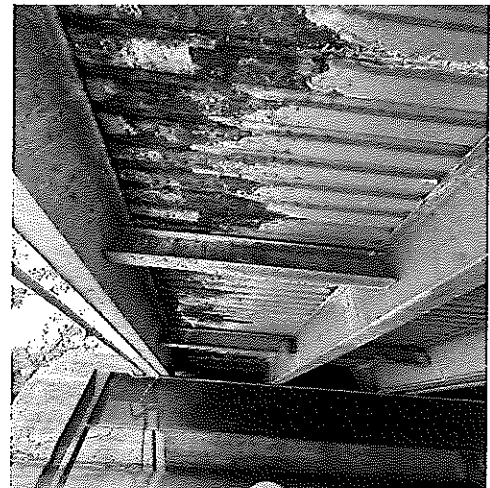
Much of the deck bottom surface is in good condition, with the outside fascia bays and end joint bay locations being in severe condition. Immediate full depth patching at these locations is necessary to prolong the service life of the bridge and prevent further deterioration.

Typical Stay-in-Place Form Fascia Rusting

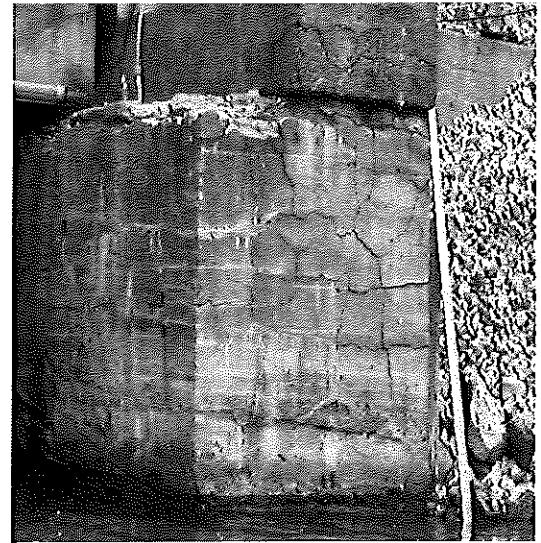
Typical Wingwall Deterioration
