ALTAMONT ENVIRONMENTAL, INC.

Lake Adger Dredging Feasibility Study Report

Polk County, North Carolina

May 20, 2015

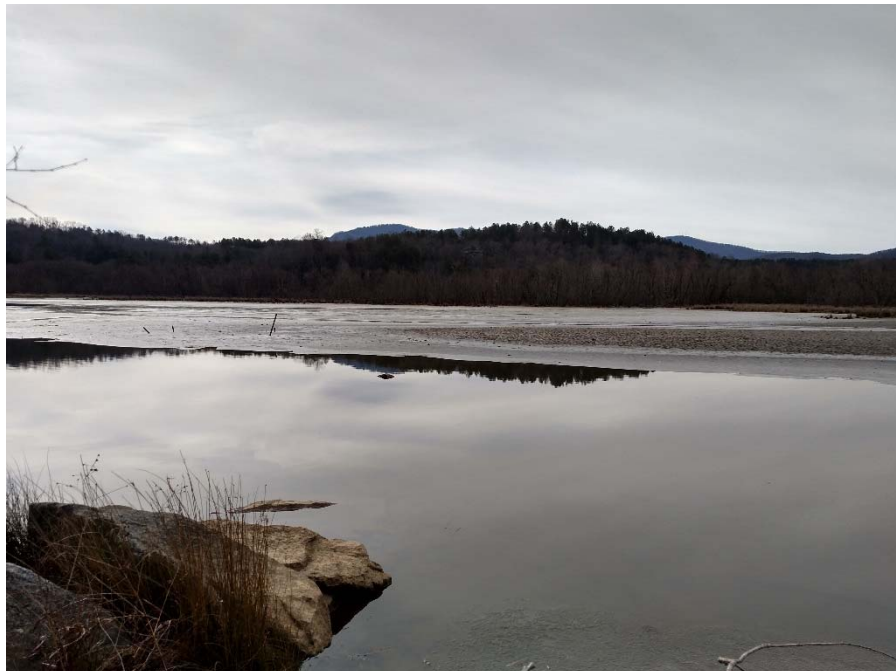
Photo 1: View of accumulated sediment in the marina basin, facing south.

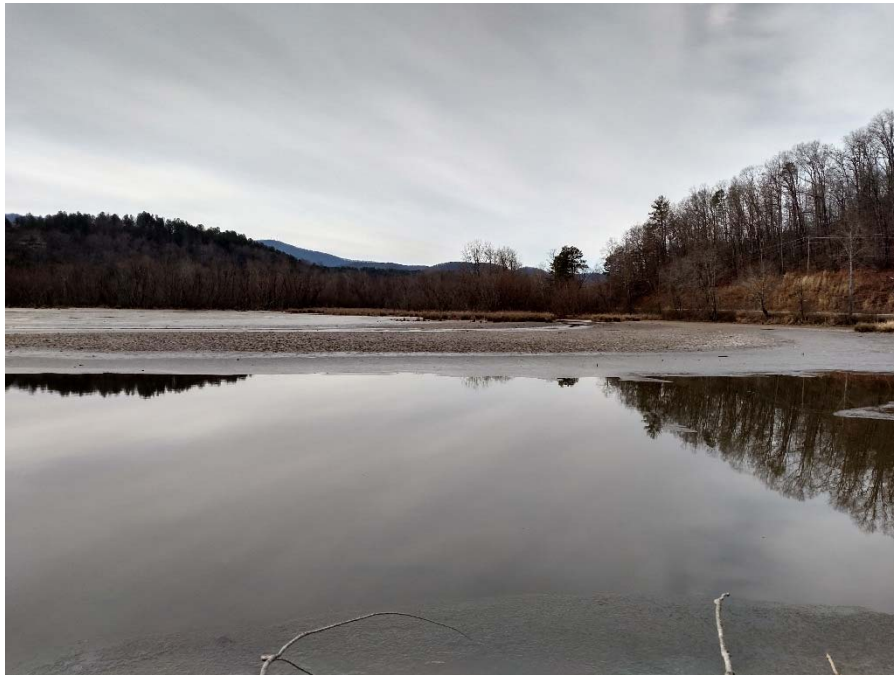
Photo 2: View of accumulated sediment west of the marina basin along Lake Adger Road, facing west.

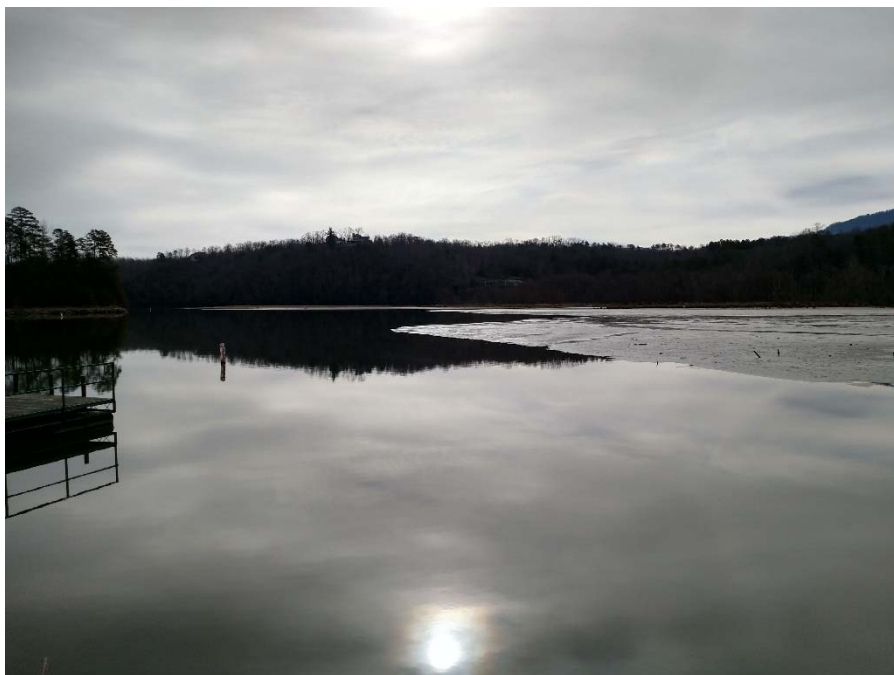
Photo 3: View of accumulated sediment in the marina basin, facing southeast.

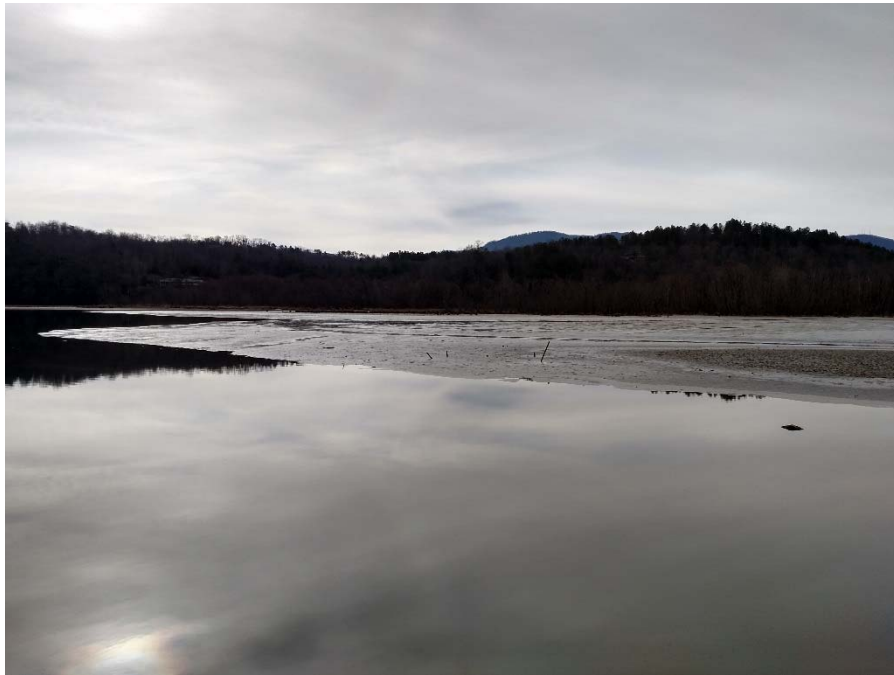
Photo 4: View of accumulated sediment in the marina basin, facing southwest.

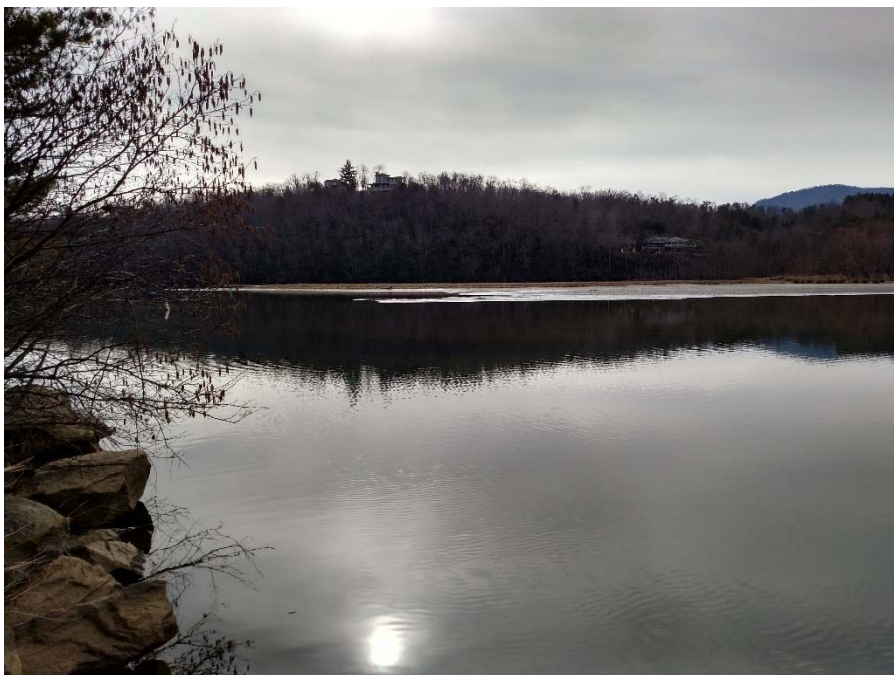
Photo 5: View of accumulated sediment in the marina basin, facing south.

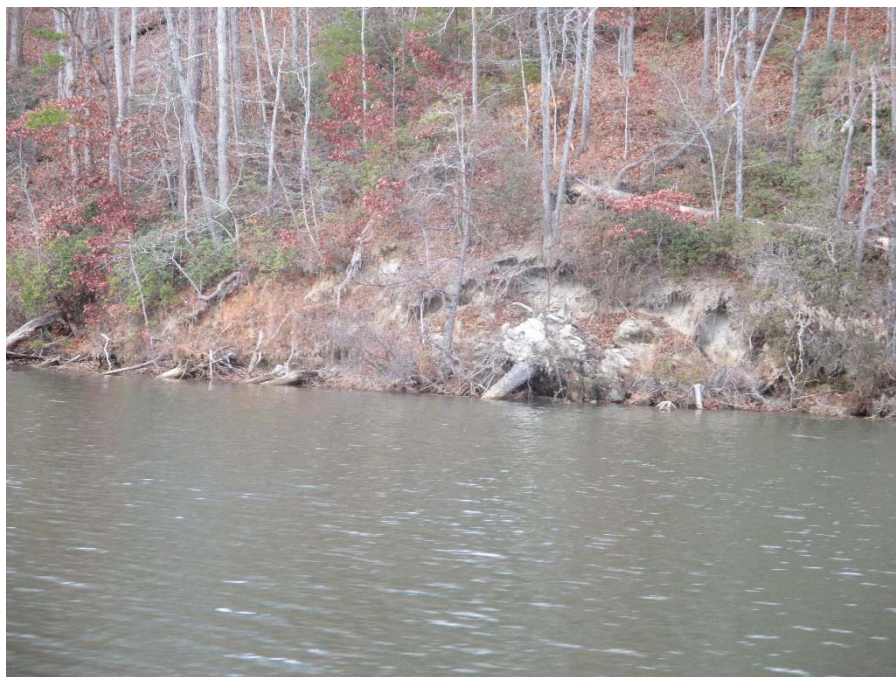
Photo 6: View of shoreline erosion.

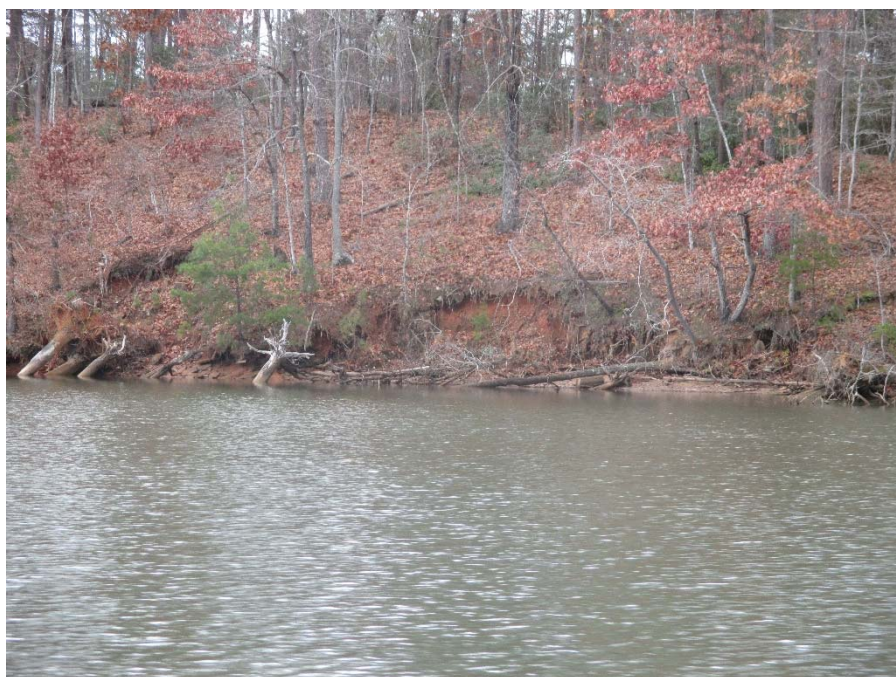
Photo 7: View of shoreline erosion.

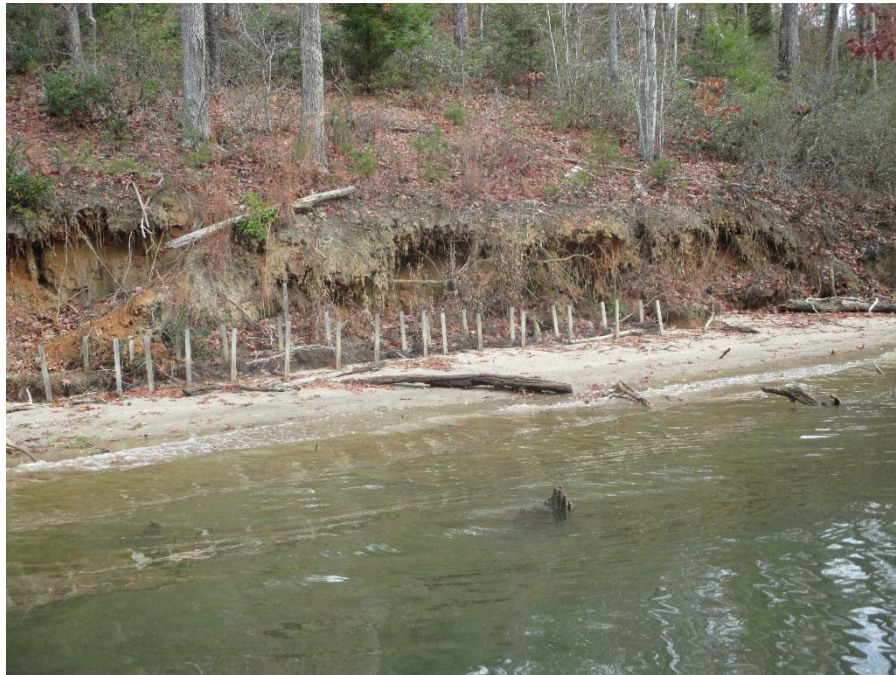
Photo 8: View of shoreline erosion.

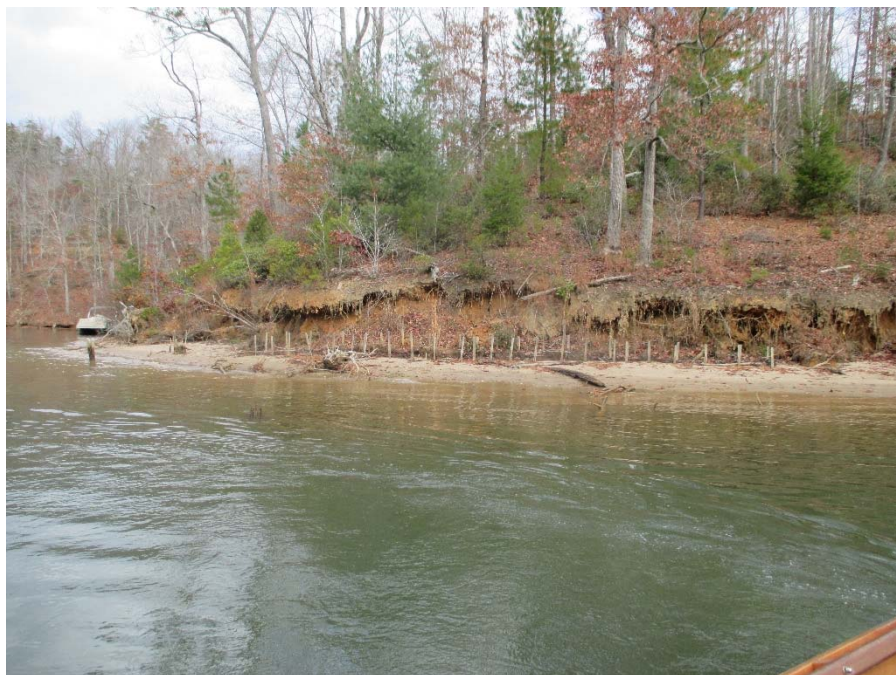
Photo 9: View of shoreline erosion.

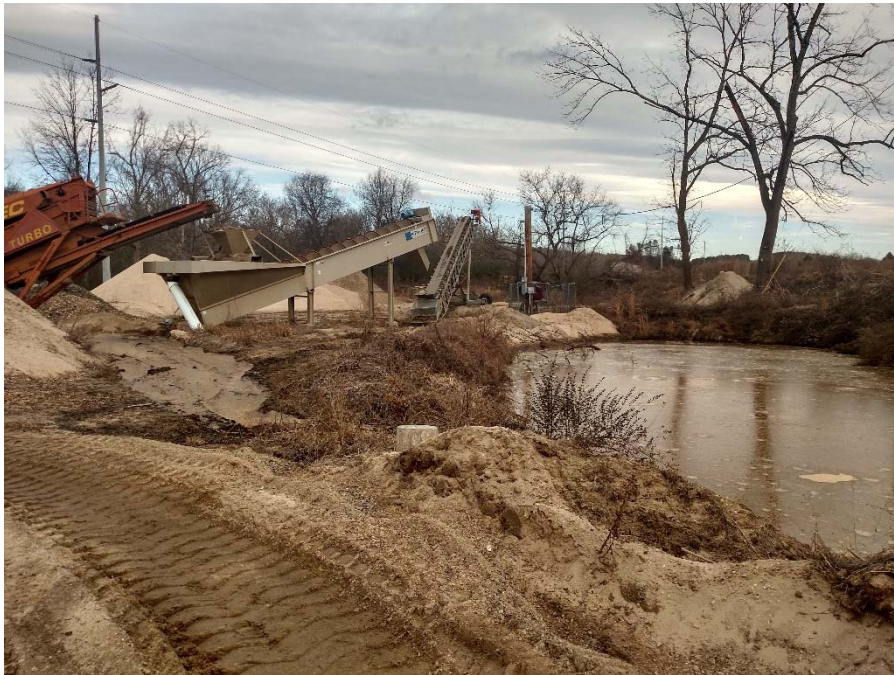
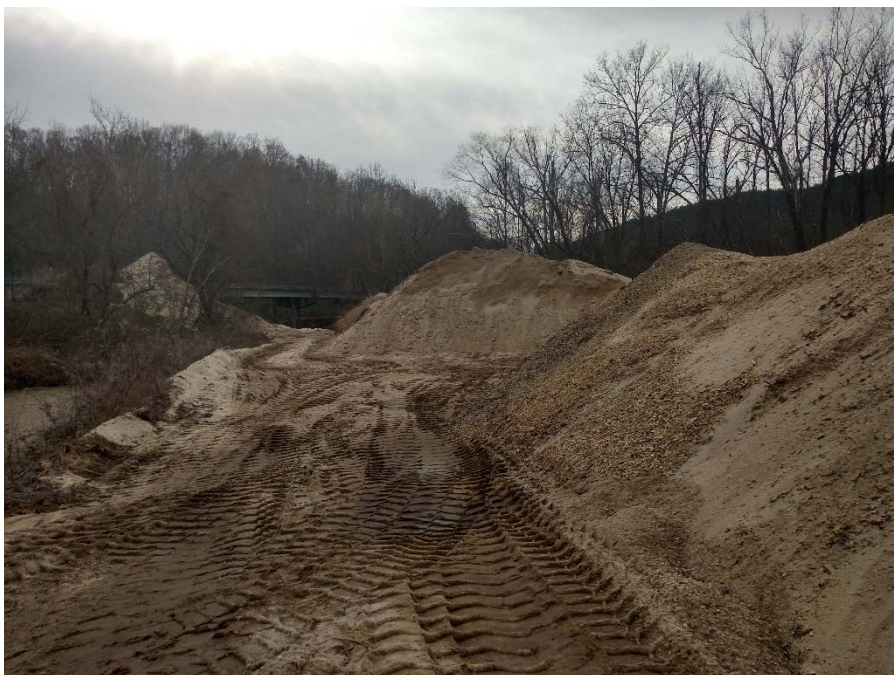
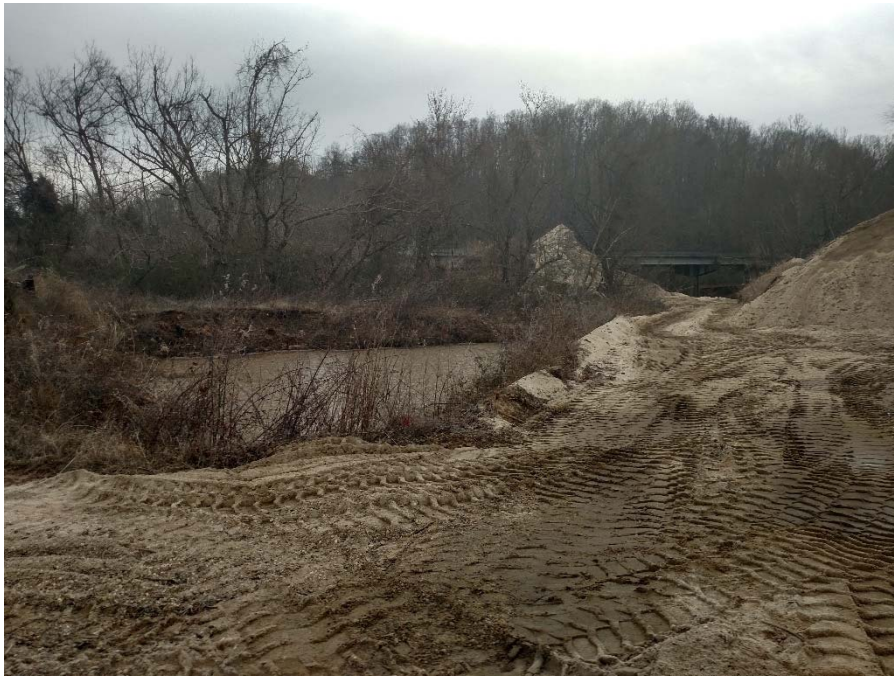
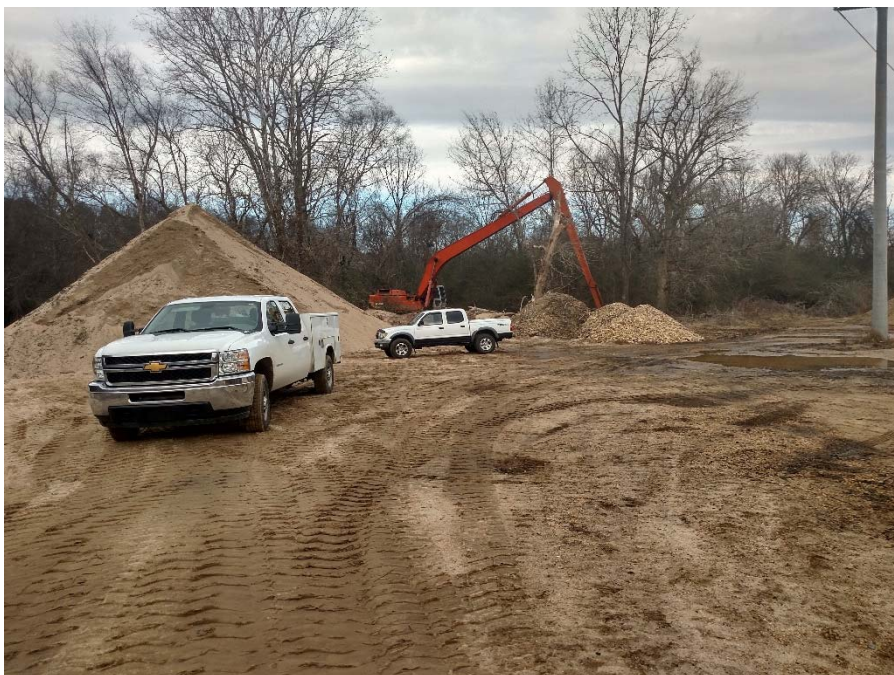
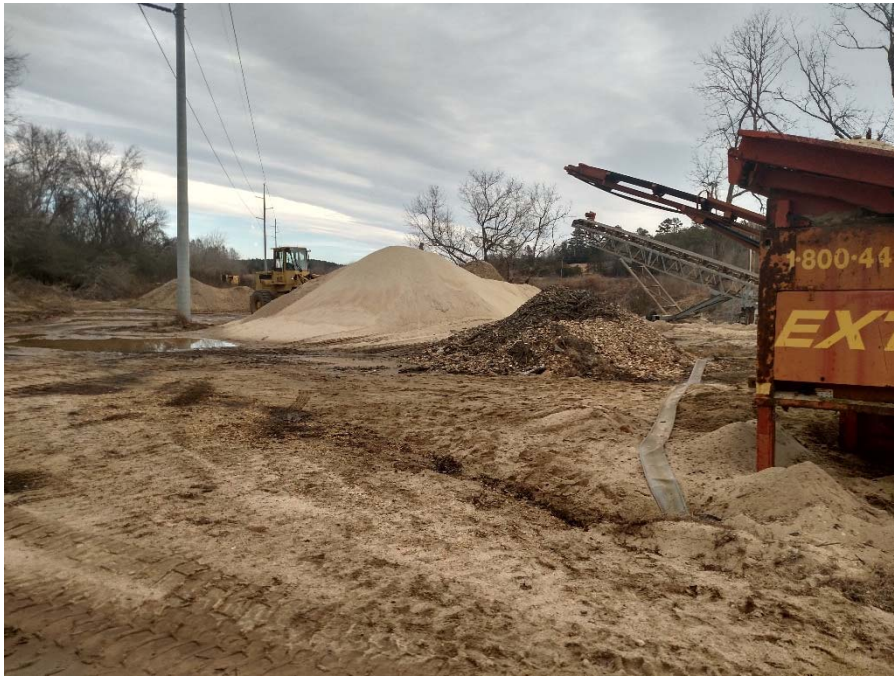
Photo 10: View of sand-and-gravel operation on the Broad River.

Photo 11: View of sand-and-gravel operation on the Broad River.

Photo 12: View of sand-and-gravel operation on the Broad River.

Photo 13: View of sand-and-gravel operation on the Broad River.

Photo 14: View of sand-and-gravel operation on the Broad River.

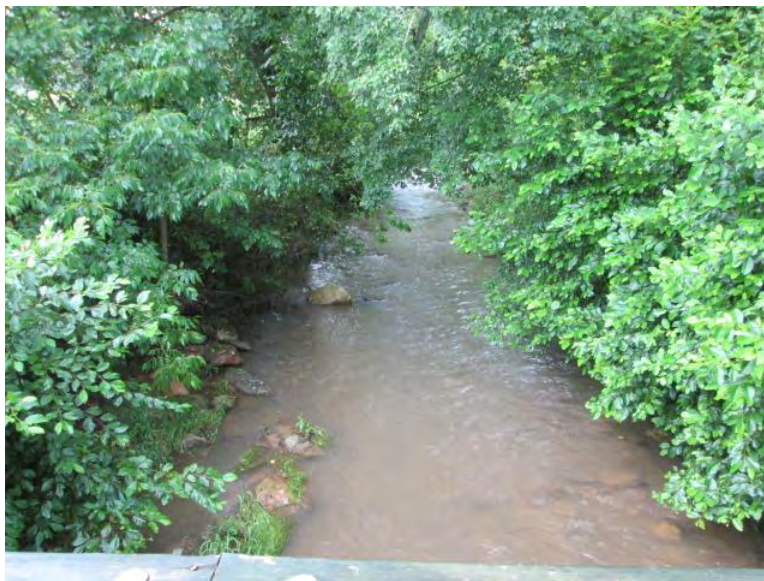
Photograph 2: View of Site 5 at Brights Creek just downstream of the Brights Creek Development detention pond observed immediately following a rain event.

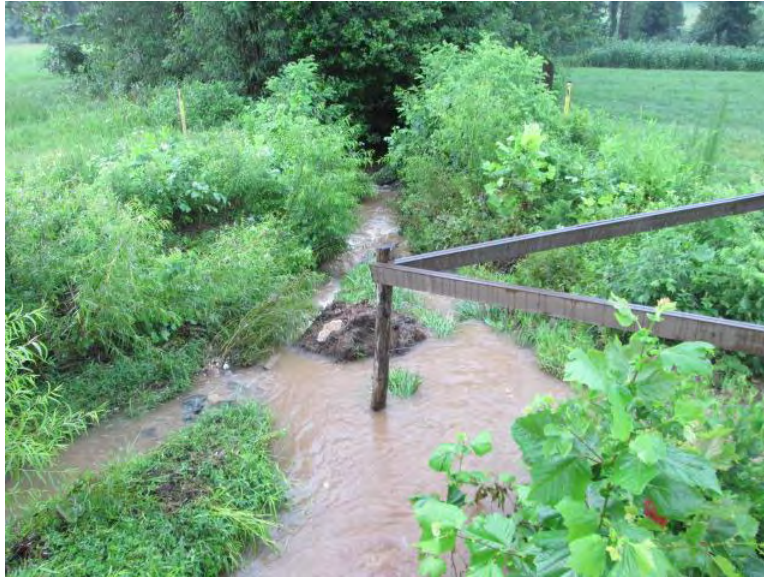
Photograph 3: View of turbid runoff from an unnamed tributary of Brights Creek, slightly downstream of Site 5, observed during a rainfall event.

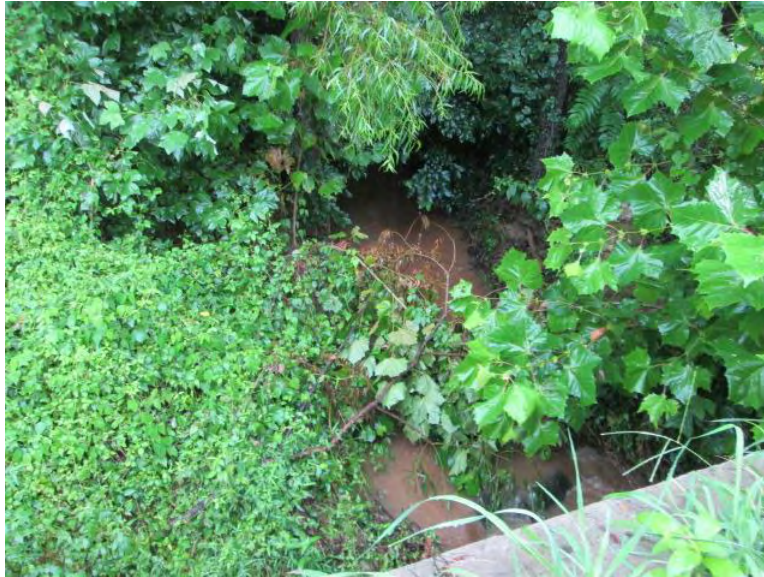
Photograph 5: View of turbid unnamed tributary to Brights Creek observed during a rainfall event on the Brights Creek Development.

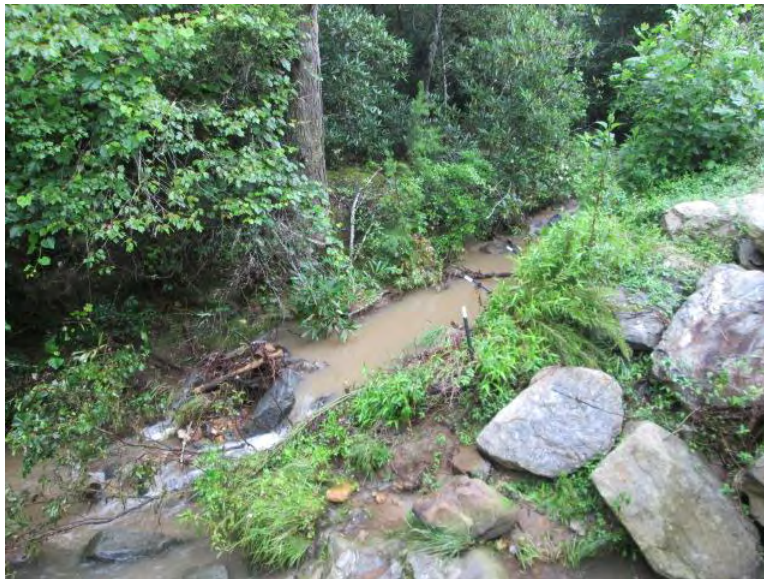
Photograph 6: View of turbid unnamed tributary to Brights Creek just downstream of the Bright's Creek Development.

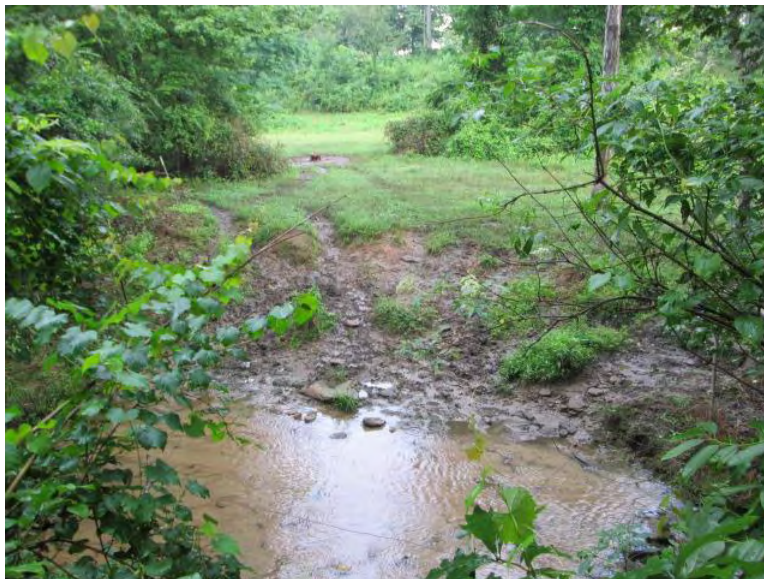
Photograph 13: View of unrestricted cattle access point along the leftbank at Site 7. Cows were observed on the property adjacent to the stream.

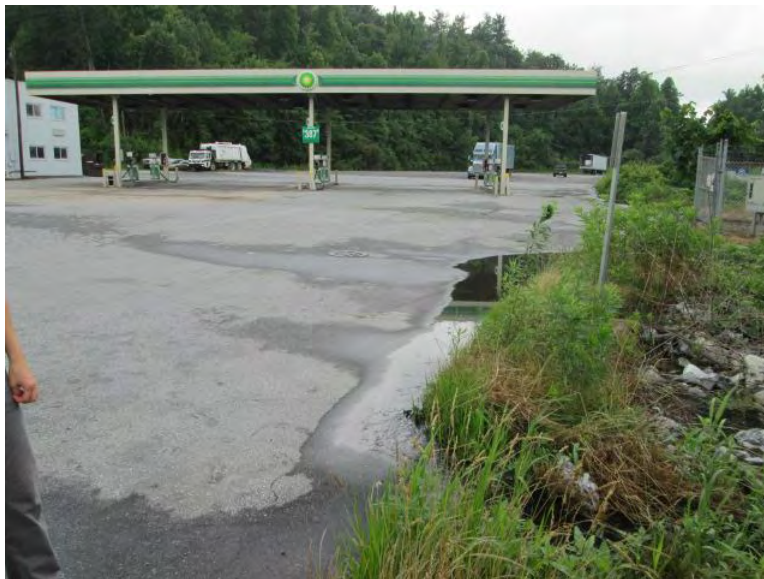
Photograph 15: View of adjacent gas station to the stream at Site 8. Asphalt was observed to be eroding on the far side of the parking lot.

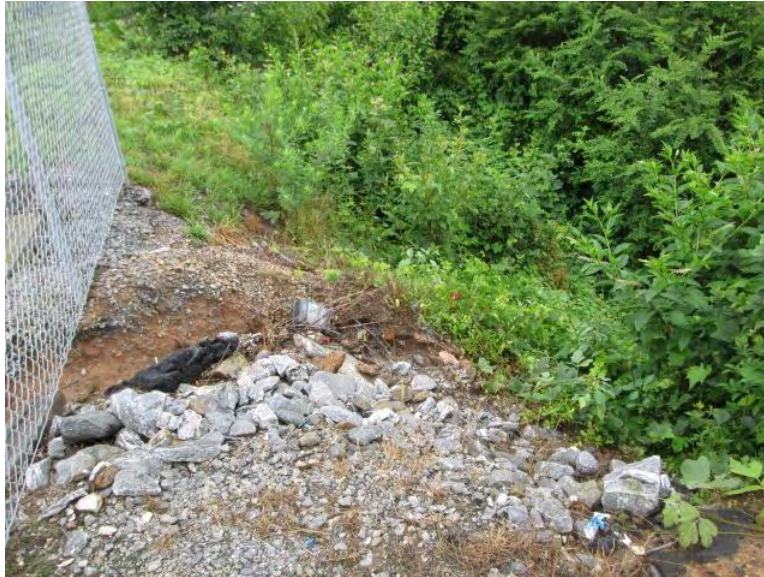
Photograph 16: View at Site 8 of eroding gully leading to an unnamed tributary to Cove Creek at the gas station.

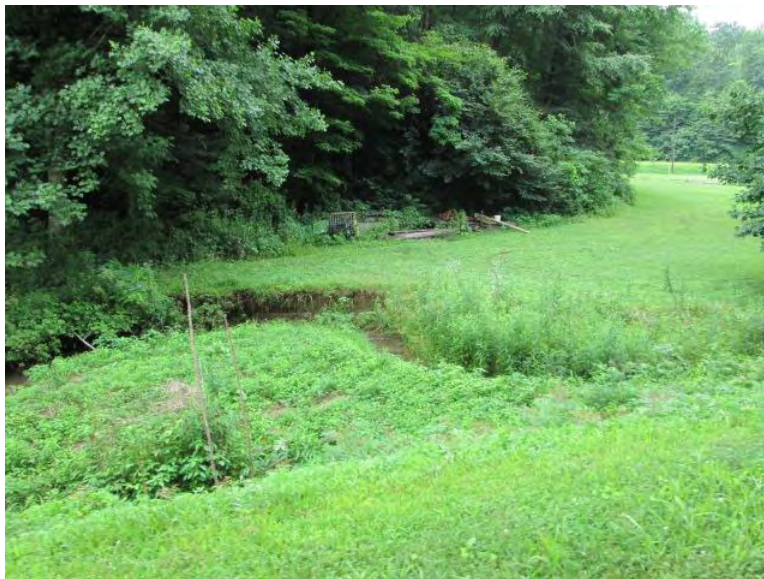
Photograph 17: Representative view of Cove Creek on private property at Site 9; the bank was observed to be eroding.

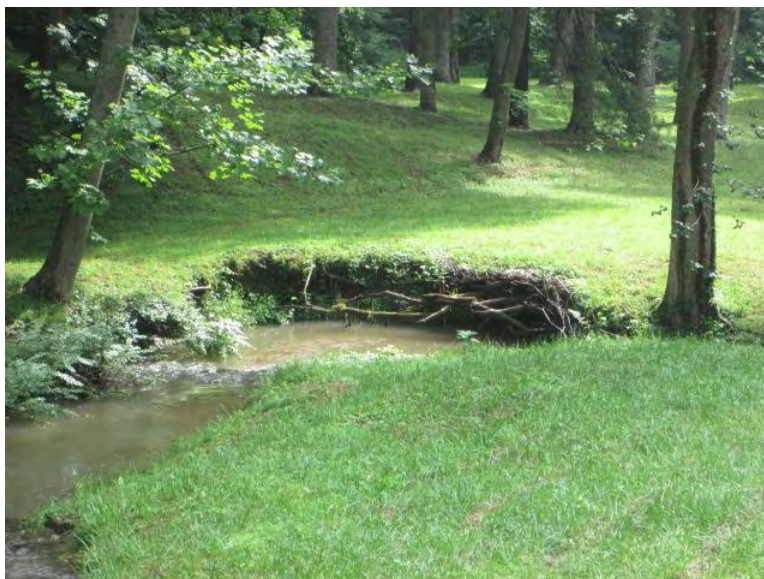
Photograph 18: Representative view of eroding bank of Cove Creek on private property on Canary Road.

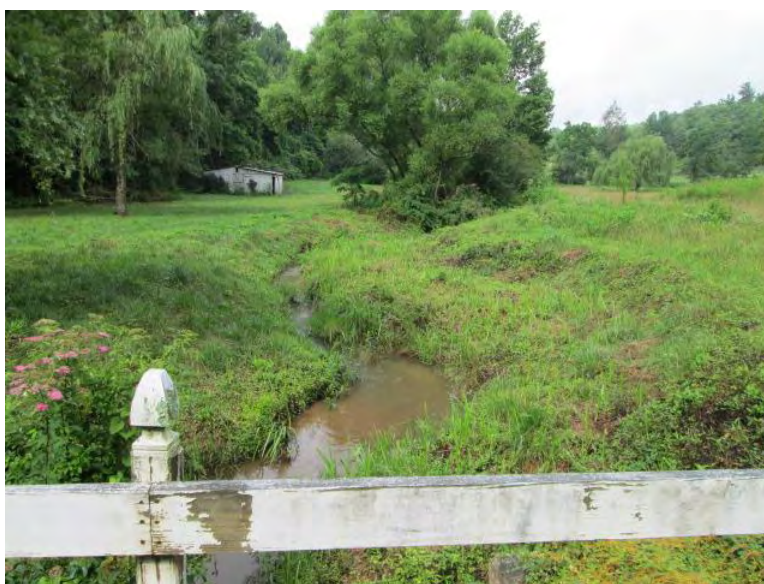
Photograph 19: Representative view of Cove Creek with no riparian buffer on private property observed from Aaybe road.

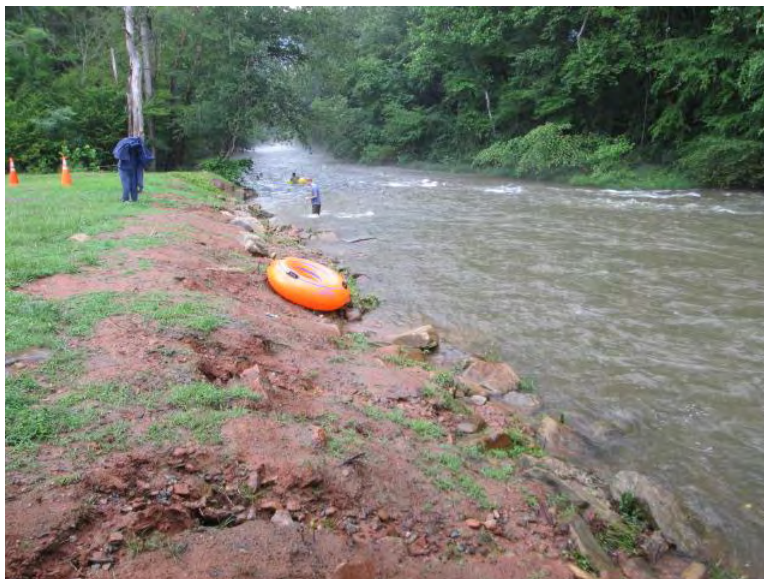
Photograph 25: View at the Green River Cove Tubing, facing downstream on the Green River. Banks were observed to be eroding.

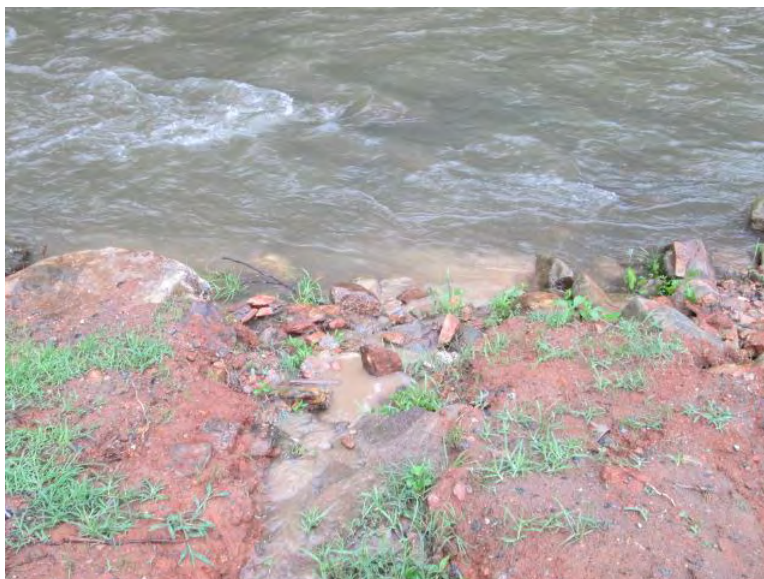
Photograph 26: View of sediment erosion on the Green River at the Green River Cove Tubing.

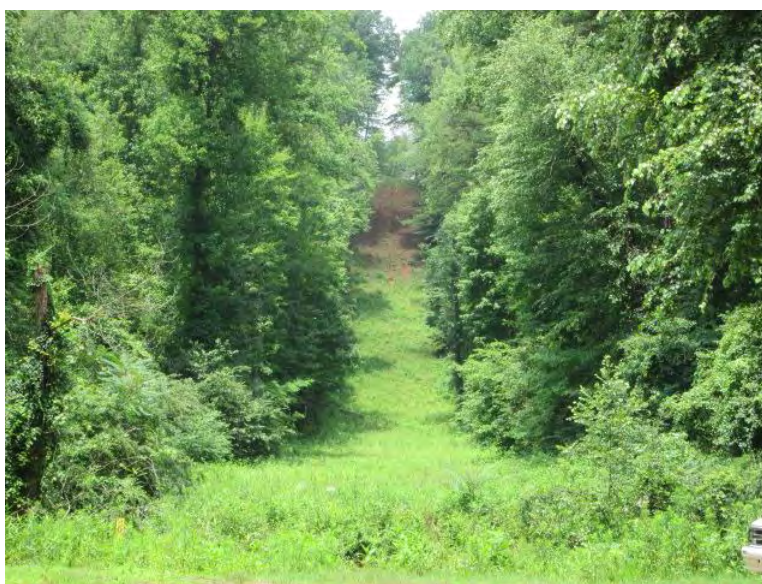
Photograph 31: View of cleared grass at gas pipe-line right of way located just downstream of tuber exit location. Note the exposed dirt near the top of the hill that is likely draining to the Green River.

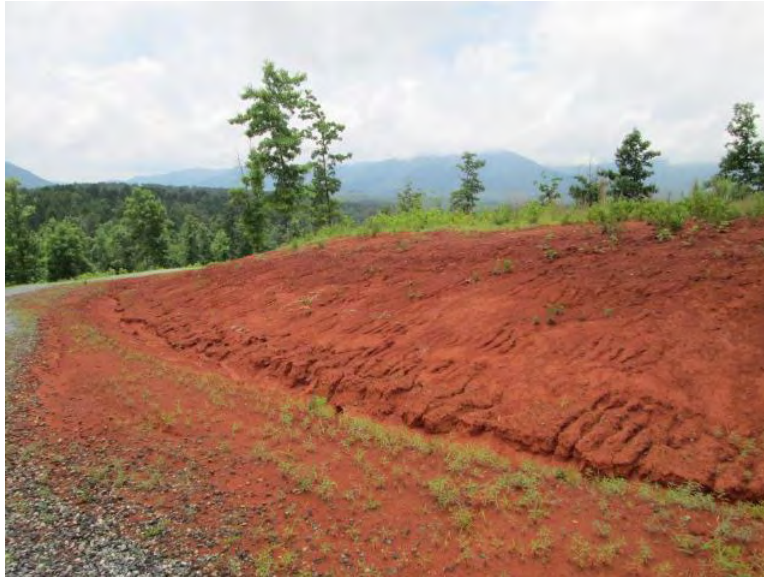
Photograph 36: Representative view of open dirt area located at Site 3. This area is located in an upland area proximate to the Green River.

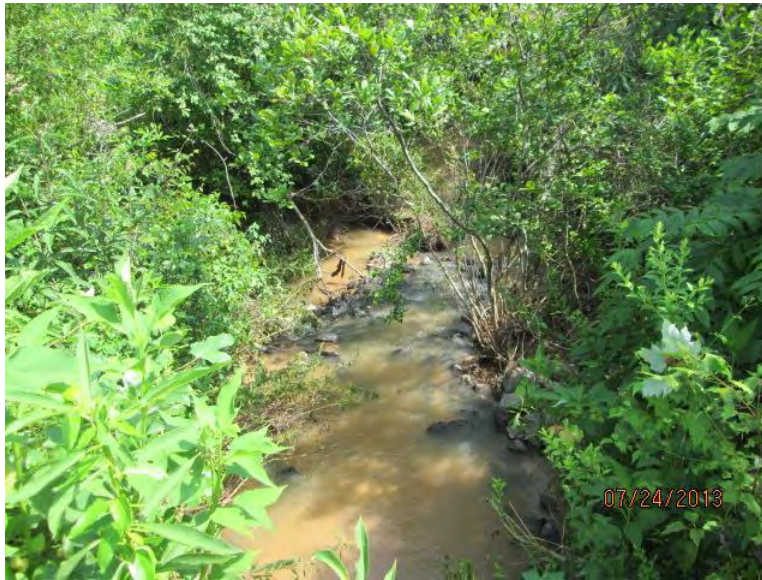
Photograph 68: View of Rotten Creek at Site 12. The stream was observed to be very turbid, even though a recent rain event had not occurred.

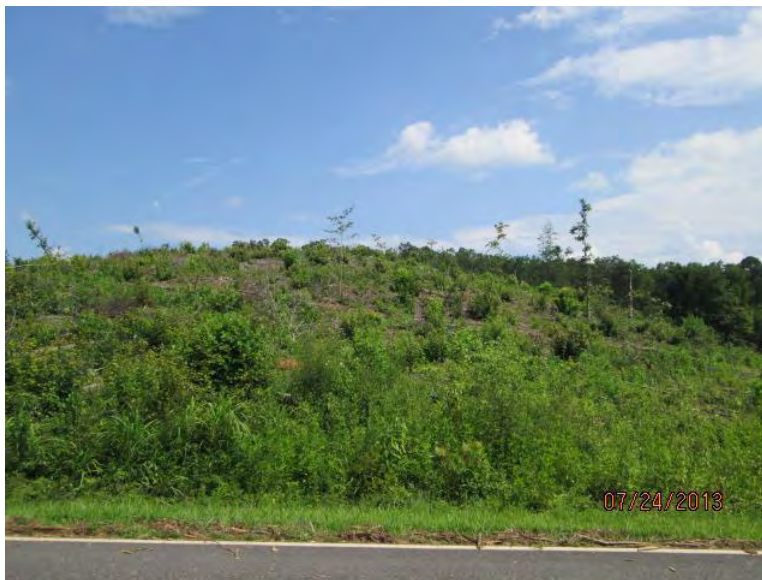
Photograph 69: View of clear-cut area near Site 12.

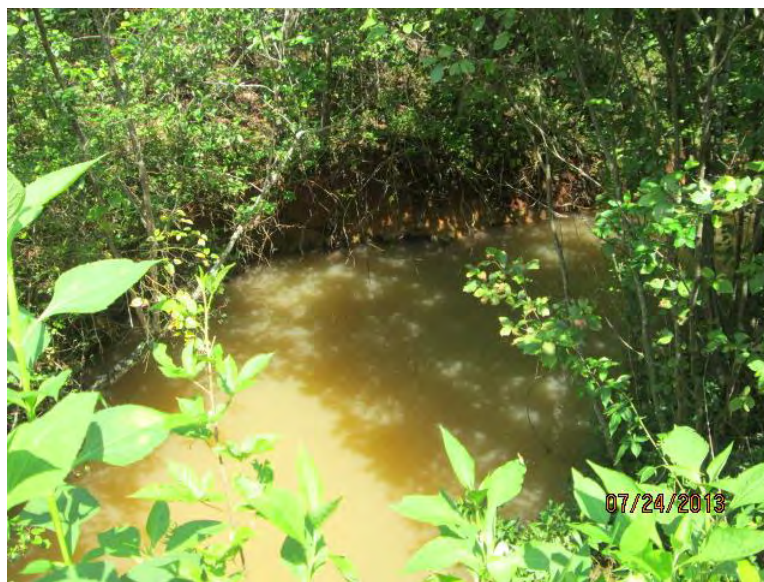
Photograph 71: View of tributary to Rotten Creek at Site 31. Sand was observed to be embedded in the channel.

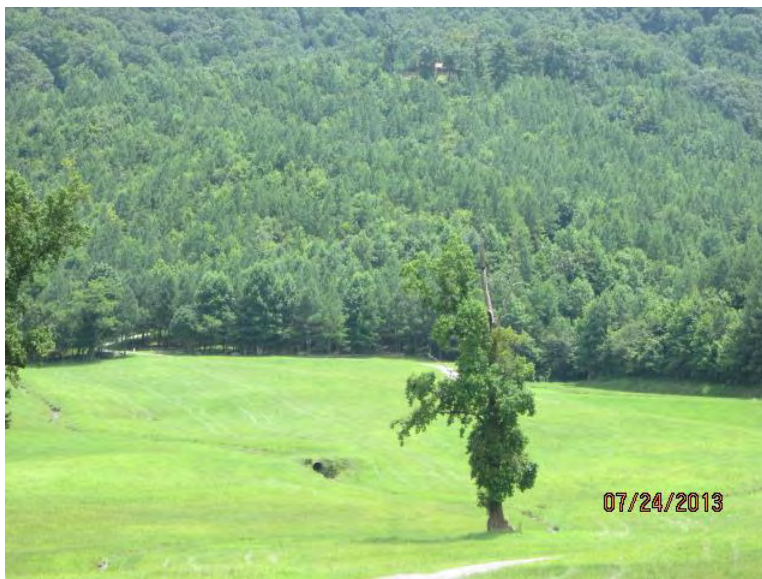
Photograph 72: View of Site 16 at the headwaters of Silver Creek on private property. No woody riparian buffer. Limited access due to private property.

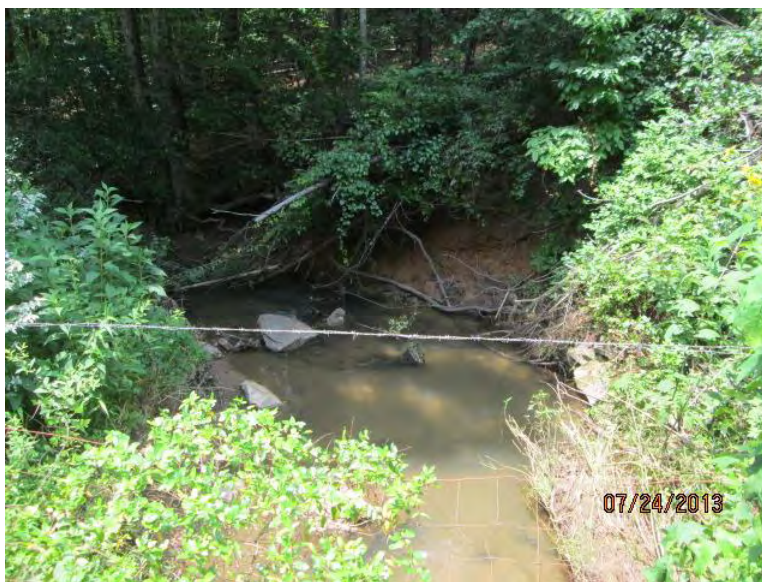
Photograph 73: View of Site 23 on Silver Creek. A tight meander and eroding bank were observed.

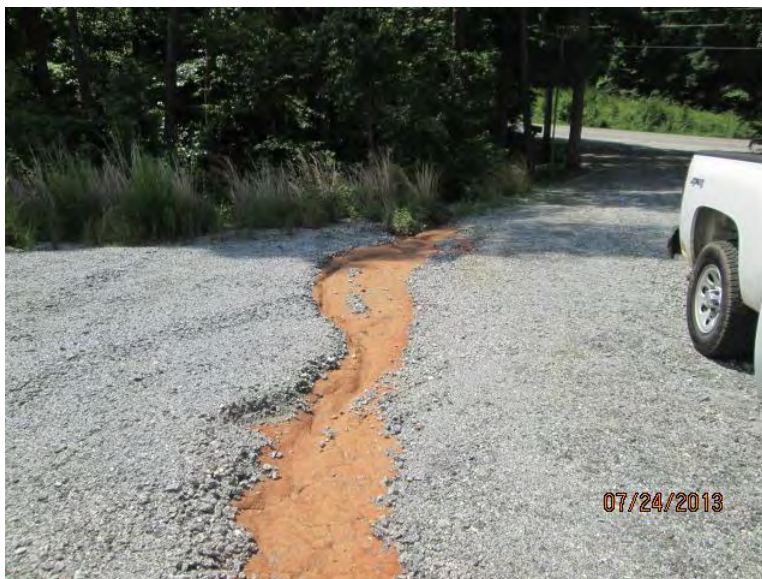
Photograph 74: Representative view of erosion on gravel road near power station near the intersection of Sylvan Lane and Silver Creek Road. Runoff from this area drains to Silver Creek.

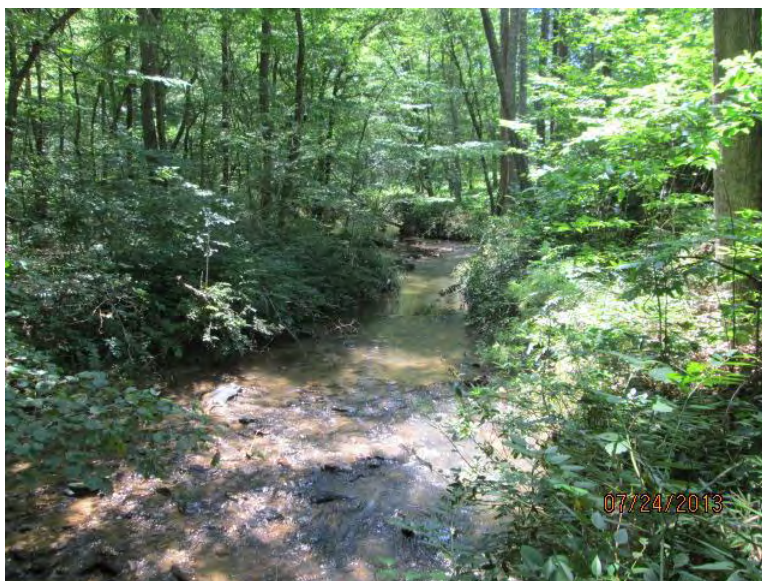
Photograph 75: View of Silver Creek at Site 25 facing downstream. The stream was observed to be clear and have some sand embedded in the channel, likely from upstream sources.

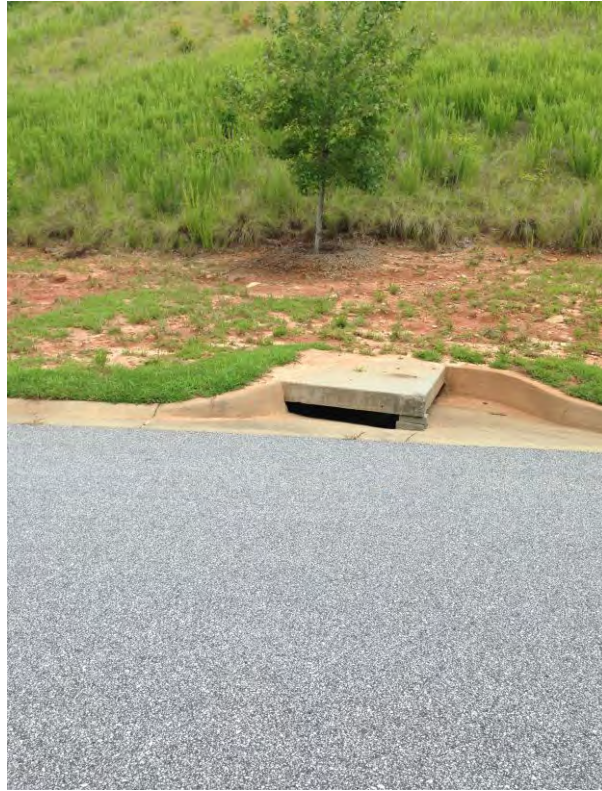
Photograph 91: View of exposed soil and stormdrain on Lake Adger development.

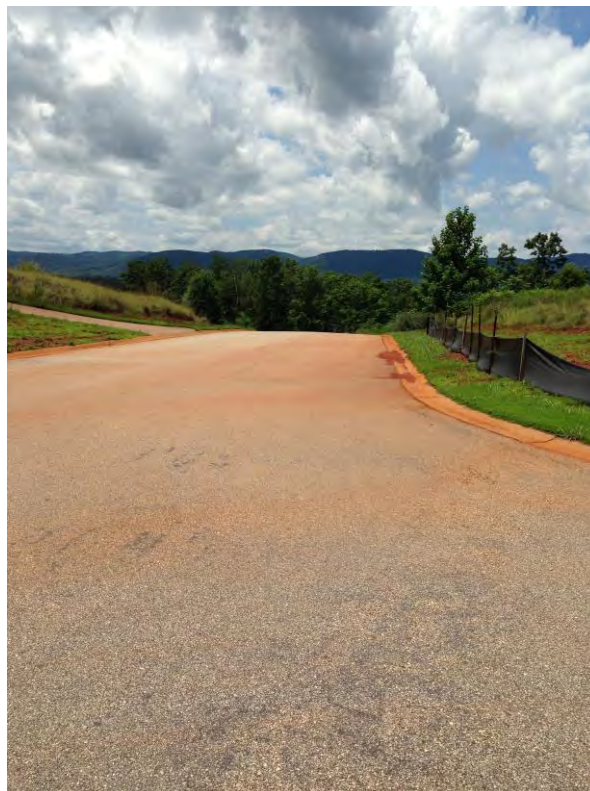
Photograph 92: View of street within Lake Adger Development following a rainfall event. Note the red sediment stained pavement indicative of sediment laden runoff.

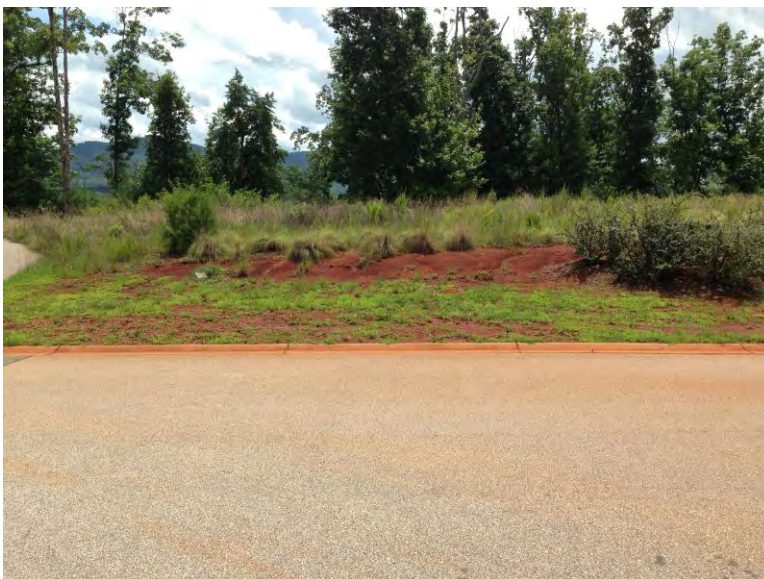
Photograph 93: View of exposed dirt and sediment stained pavement within Lake Adger Development following a rainfall event.

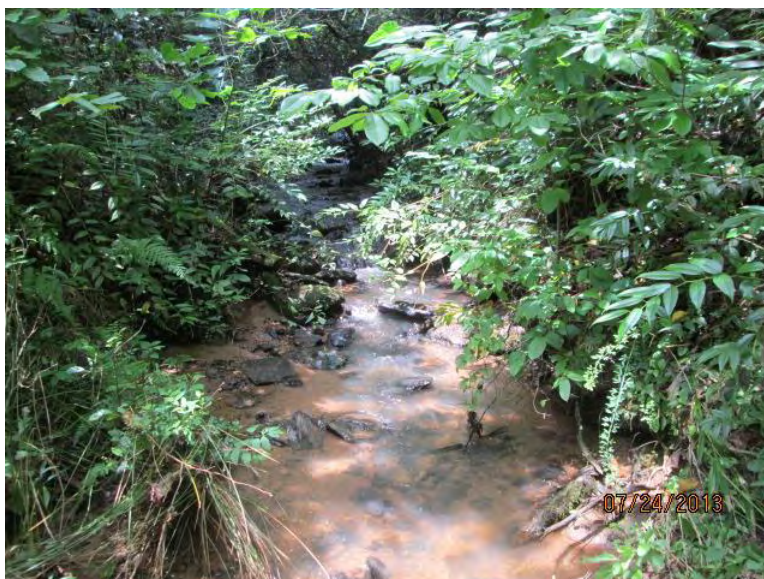
Photograph 94: View of tributary to Lake Adger at Site 4 facing upstream. This stream appeared stable, although the sediment observed in the stream was more turbid than other locations observed on the same day.
