BRIDGE INSPECTION REPORT

Date Inspected: May 20th to May 23rd, 2024

Grosse Ile Toll Bridge

Structure Number: 12306

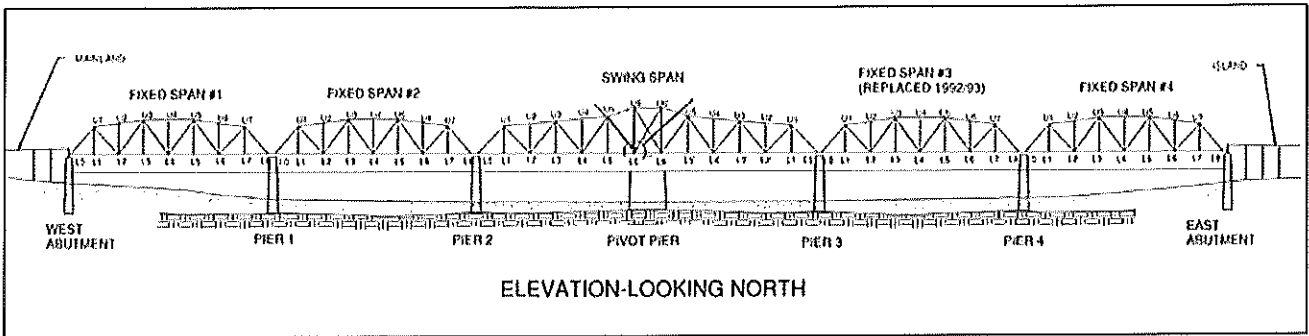
Elevation of Grosse Ile Toll Bridge including naming conventions

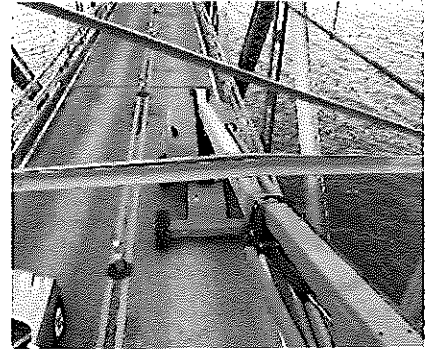
Photo S-10 [Span 1] Bent sway bracing between north and south truss at PP U6, looking east

[REDACTED]. The sway bracing angle between the north and south truss at PP U6 of Span 1 is bent [REDACTED]

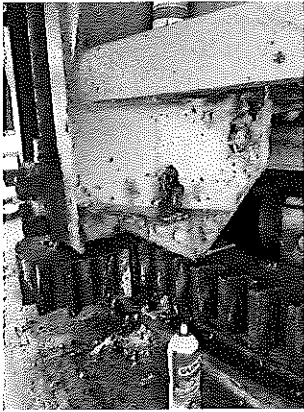
M14: Glass between rack and pinion

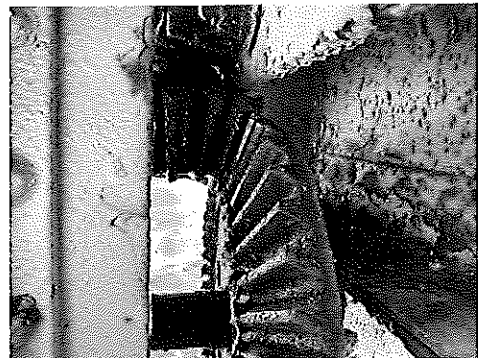
M25: BP3/BG3 – West

BP3 and BG3 comprise the second set of bevel gears at the end lift machinery rest piers. The gear teeth are difficult to access and therefore were not cleaned and measured. The gearset on the west side appears to be misaligned as shown in Photo M25. The gearset on the east side is also severely misaligned. Photo M27 shows the shafting for BG3 –

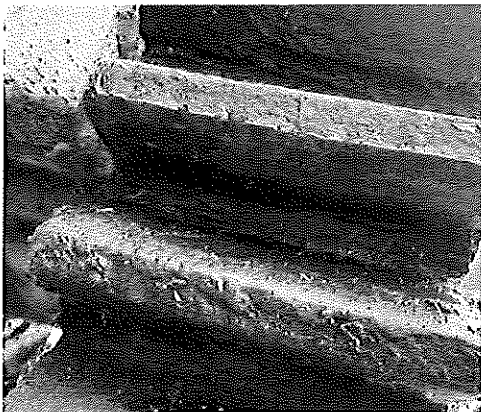
M32: G5 – NE

The backlash for these gears was inaccessible for measurement but the NE gearset is estimated to have about a half an inch of backlash.

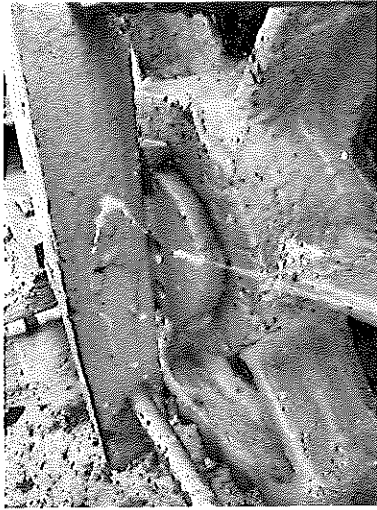
M36: NE key interfering with ladder

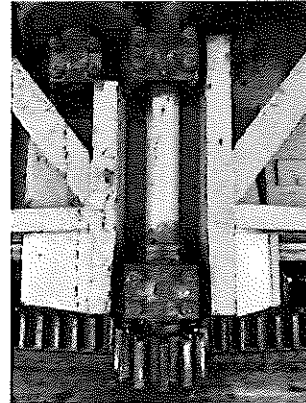
M50: West Bearing B7 & B8

[REDACTED] However, the fasteners are very corroded. There is a significant amount of pack rust causing the threading to be about a quarter of the way through the nut on bearing B8. Bearings B7 and B8 are shown in Photo M50 below.

All end lift machinery bearing clearances were measured where accessible. Overall, the bearings are in poor to fair condition. There is pack rust between the bearings and the bearing support beams, and the fasteners are corroded.

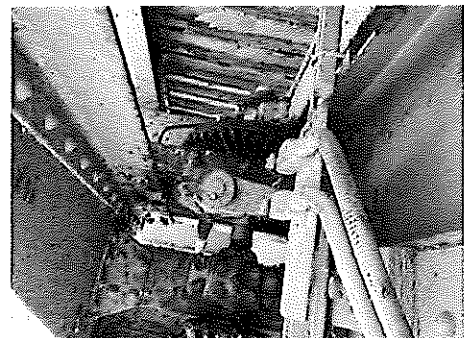
M65: Clearance at pin – West

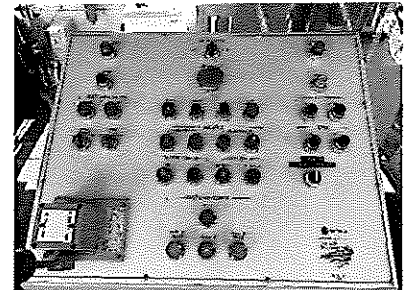
The span control system consists of an Allen Bradley SLC500 PLC connected to an Allen Bradley PowerFlex 700 adjustable frequency drive. The control console houses the PLC, and the drive is mounted in a separate enclosure. The control console appears well laid out and is of substantial construction (Photo E-4). The PLC is provided with position information from two absolute binary position optical encoders, one coupled to the original end lift mechanical indicator to provide end lift information, and one in the machinery space attached to the span and coupled to the span center pin to provide span position information. A Gemco rotary cam limit switch is provided for overtravel indication (Photo E-5). It was noted that the traffic signals and warning gates are not interlocked with the span control system in violation of AASHTO.

Photo E-4 [Operator's House]
Main control console

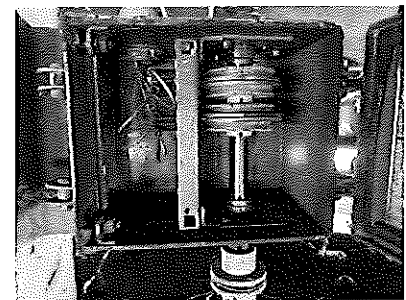
Photo E-5 [Machinery Room]
Typical Gemco rotary cam limit switch

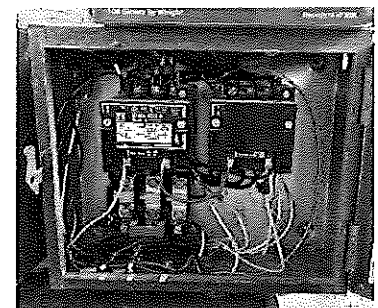
The warning gates are operated by switch stations either in the Operator's house or on the wall of the tender's house. These switches were originally connected to NEMA size 0 starters in the operator's house (Photo E-6) but are now connected directly to starters located in the warning gates. The gates have latching circuits such that once the switch is momentarily placed in the lower position, the gates will lower unless the stop button is depressed. On movable bridges, operators often must hold the gate switches in the "lower" position to keep their attention on the lowering gate and stop in the event a car was continue when closing traffic. There is a latched group raise feature, which is normal procedure with raising gates. The starters are fed through a 60-amp three pole fused disconnect on the line side of the main motor disconnect. It is wired with No. 10 AWG conductors between the disconnect and the starters; wiring by code should be No. 6 AWG. The emergency drive starters are fed from the same circuit that feeds the gate starters. Pendant control stations are mounted on the wall of the tender's house.

Photo E-6 [Operator's House]
Typical disconnected NEMA
Size 0 starter

SHORT-TERM RECOMMENDATIONS	
Work Activity	Description
Motors	Modify motor span control to have motor drive ramp motor to a full stop before setting motor brakes.
Control System	Remove latching lowering circuit from gate controls.
Submarine Cables	Repair detached submarine cable ducts.

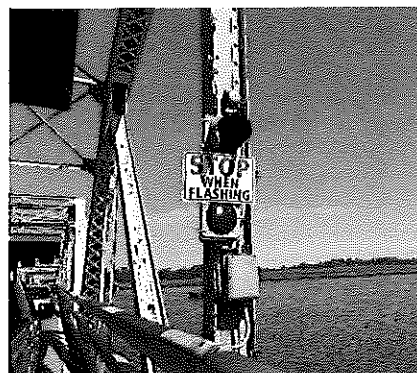
Photo E-7 [Span 3] Typical stop light

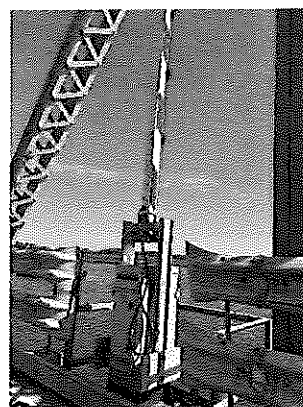
The gate arms were manually moved to check the linkages and ball joints. The linkages were in good condition.

Photo E-8 [Span 3] Typical traffic gate

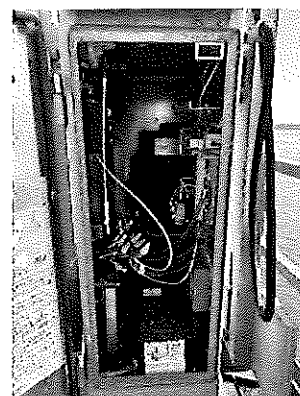
The gate housings are in good condition. The interiors of the housings are relatively clean.

Photo E-9 [Span 3] Typical traffic gate housing

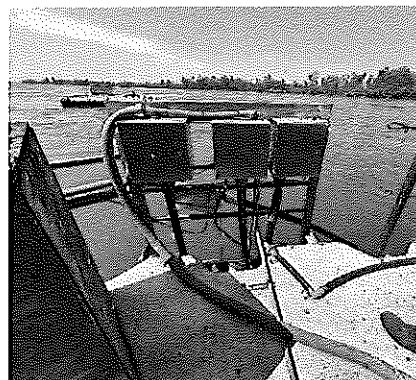
Photo E-10 [Pivot Pier]
Submarine cable enclosures

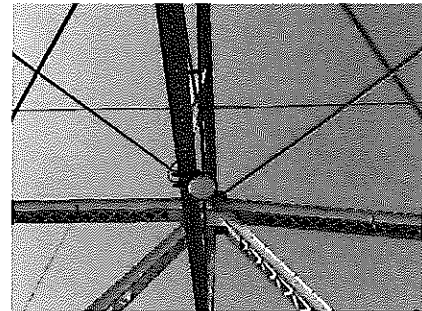
Photo E-13 [Span 3] Typical overhead LED roadway lighting

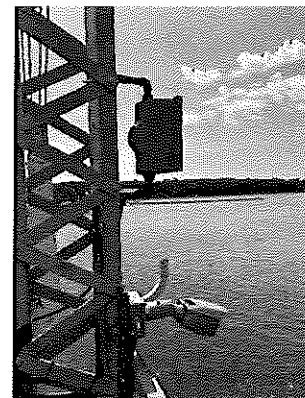
Photo E-14 [Span 2] Typical closed-circuit camera

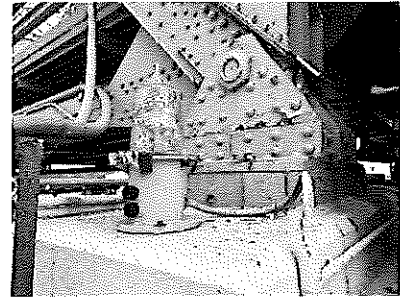
Photo E-15 [Pier 3] Typical navigation lighting

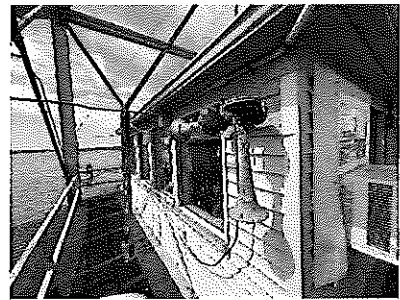
Photo E-16 [Operator's House] Air horn

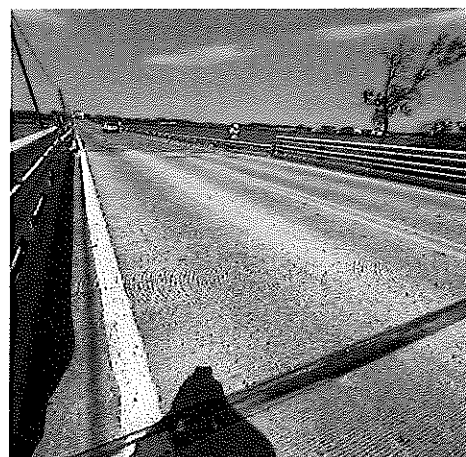
Tined reinforced concrete deck (10") that spans a portion of the Detroit River. New deck was poured during 2001 superstructure replacement. No visible spalling or delaminations on the surface, minor edge spalls located at expansion joints on both ends of bridge. Continuous steel bent plate $\frac{1}{4}$ "x6" is welded to the top flange of both fascia beams and extends up the deck fascia. Water is infiltrating between the deck fascia and steel bent plate which is causing deterioration along the deck bottom surface stay-in-place forms (see Deck Bottom Surface description).

Typical Deck Surface

The deck surface is in good condition with no immediate repairs along the surface recommended. Immediate full depth patching will be needed based on stay-in-place form deficiencies. It is recommended that in 5-10 years a deck replacement could be needed depending on the severity of the deck bottom surface deficiencies at that time.

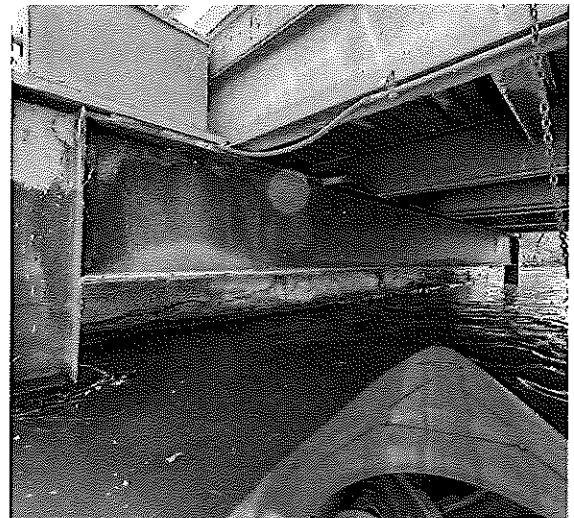
Typical Steel Bent Cross Girder
